‘The general appearance of things is as of old’: The Colenso homestead at Bishopstowe

A significant historical site

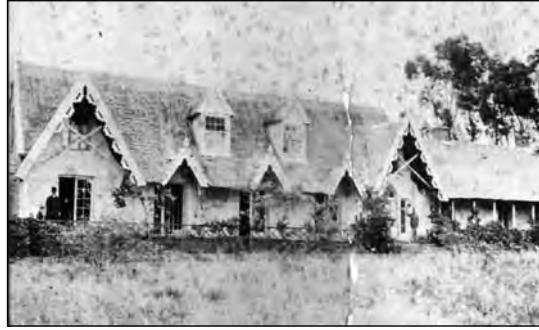
Fig 2. View of the east front of the house of 1854 to the right and the conjoined one of 1858 on the left.

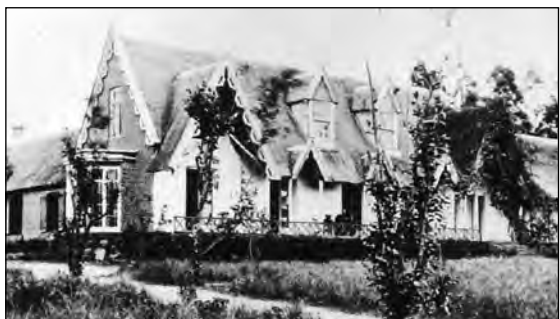
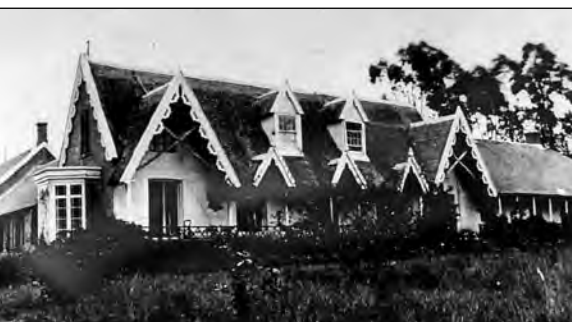
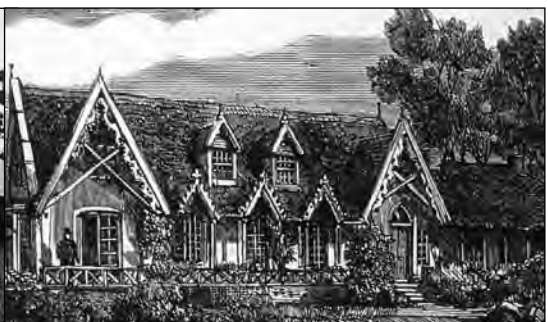
Figs 3–5. Various views of the 1854 and 1858 houses from the east.

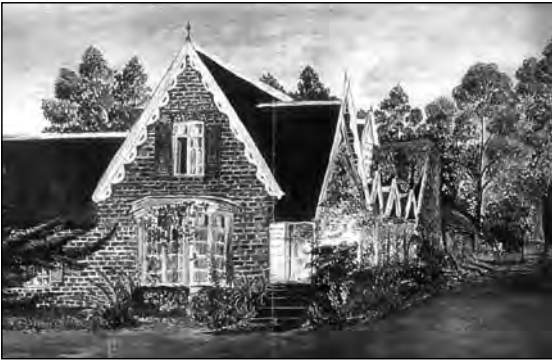
Fig 6. A painting by Clarke of 1883 showing the south and east sides of the 1858 house.

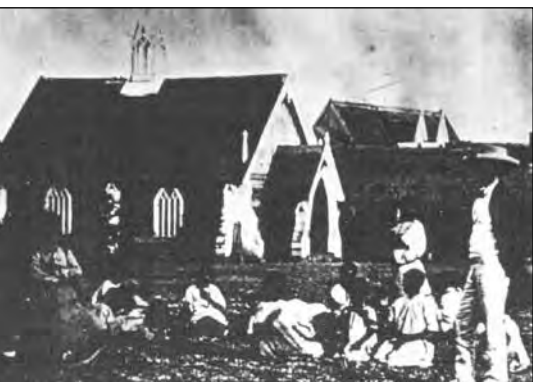
Fig 7. The yellowwood chapel from the north with the 1858 house in the background.

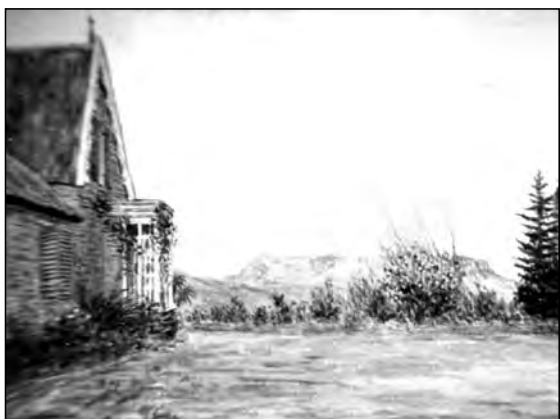
Fig 8. A painting by Clarke of 1883 looking past the south side with Table Mountain in the distance.

view of Table Mountain to the east. [Fig. 8] In between his numerous travels this was where Bishop Colenso worked and lived, often in his study with its fine view of a Natal landscape:

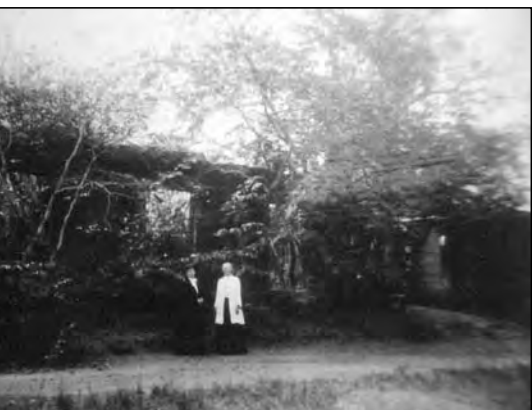
Fig 9. Harriette and Agnes Colenso outside the ruined east front of the 1858 house.

confirms the existence of a veranda along the court side of the house, but the long passage is not easy to determine. Harriette's letter to Frank and his wife Sophie of 8 September provided vivid images of how she had rescued Bishop Colenso's most important documents and the destruction by fire of various artefacts, items of furniture in the main rooms and paintings. '...The heat was so intense that the glass, windows, bottles, inkstands, everything is run together and twisted...' [Fig.9]

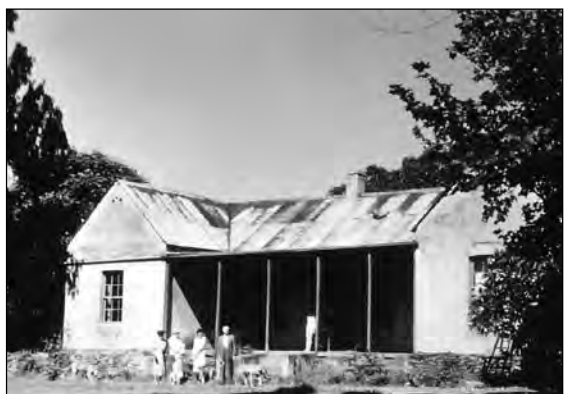
Fig 10. The house built by Harriette and Agnes shortly before 1900.

opstowe. Reflecting the difficult times and their own delicate political situation, this was a much more austere house with a small front veranda flanked by two gables which would have been described in the Cape as a stoep-kamer house.²⁴ It also stood facing the same view of the garden and the distant landscape. [Fig. 10]

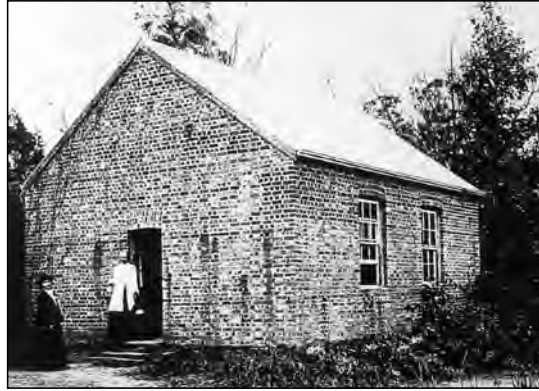
Fig 11. Harriette and Agnes at the west end of the reconstructed brick chapel.

down Harry and I rebuilt the old part of the house, just taking in the front steps (not the new part, i.e. study, drawing and the bed rooms in that wing) and quite separate by itself the dining room which we use as church and school. When it is too hot and the congregation is over 300 and can't get into the building we carry forms and harmonium down to the oak grove, which makes a lovely church for Xmas and Easter etc...²⁸ [Fig. 11]

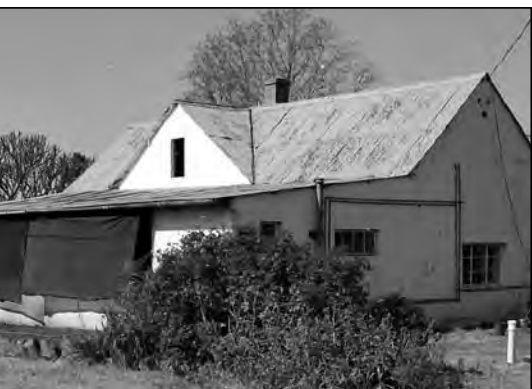
Fig 12. A view of the house from the north in 1995.

During the remainder of the twentieth century this house was used by a number of owners as a farmhouse and underwent many changes, sufficient to constitute it as the fourth house. A large veranda was built on the north side and then enclosed. Several rooms were subdivided and the original timber sliding sash windows were replaced with steel casements. Many details were also altered. The original chapel-cum-school room, the lower walls of which had survived the fire, had been rebuilt by Harriette and Agnes and became a barn and a number of lean-to structures were built around it. Most of these building alterations were carried out without any regard for the character or integrity of the original late nineteenth century building, yet nevertheless represented in a crude way

a fairly typical rambling farmhouse. This was what the Restoration Committee was faced with and which became the object of an interesting 'forensic' study. [Fig. 12]

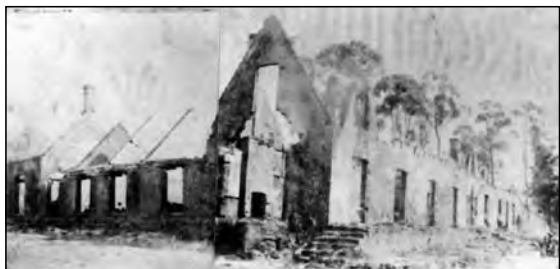
Fig 13. Photographs of the south and east end of the house joined together to show the exterior after the 1884 fire.

Fortunately a series of photographs were taken of the Bishopstowe ruins shortly after the 1884 fire. [Figs.13–16] These provided not only a clear outline of the skeleton of the conjoined houses of 1854 and 1858, but also useful details of interiors, masonry courses, fireplaces and doors and windows. Using photographs which showed both the skeletal east and south faces and converting this into a line

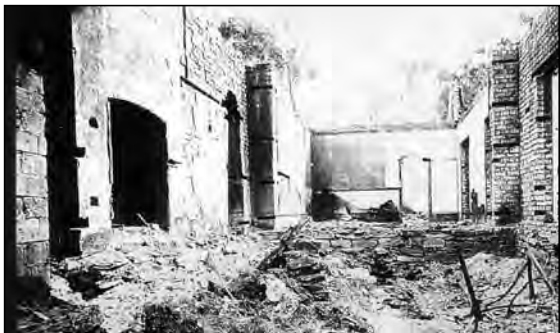
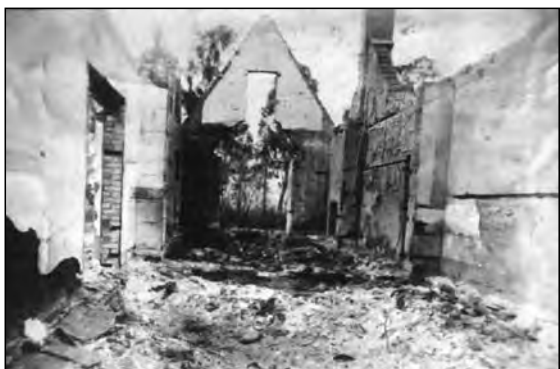
Fig 14–15. Two views of the drawing room after the fire.

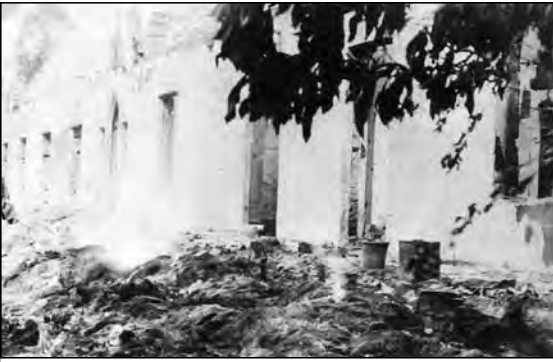
Fig 16. A view along the east front showing the windows of the principal rooms and the front door, with pointed arch, after the fire.

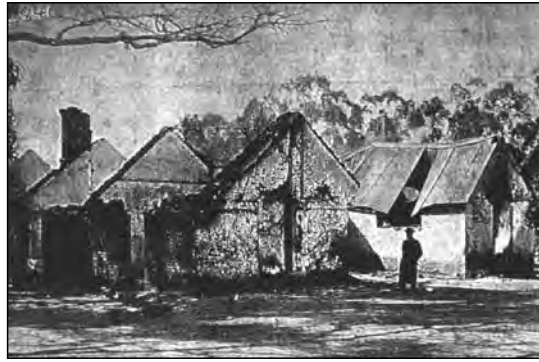
Fig 18. A photograph of the north side and courtyard of the house after the fire. The building on the right, with a corrugated iron roof, was probably the second detached kitchen.

drawing allowed a rudimentary plan to be developed. Further photographs from different viewpoints were also converted into line drawings and provided more information about the plan. [Figs. 17–18]
